# COAL ASH IMPOUNDMENT SITE ASSESSMENT DRAFT REPORT

**F. B. Culley Power Generating Station  
Vectren Corporation  
Newburgh, Indiana**

KLEINFELDER PROJECT NUMBER 112618-1

**September 2010**

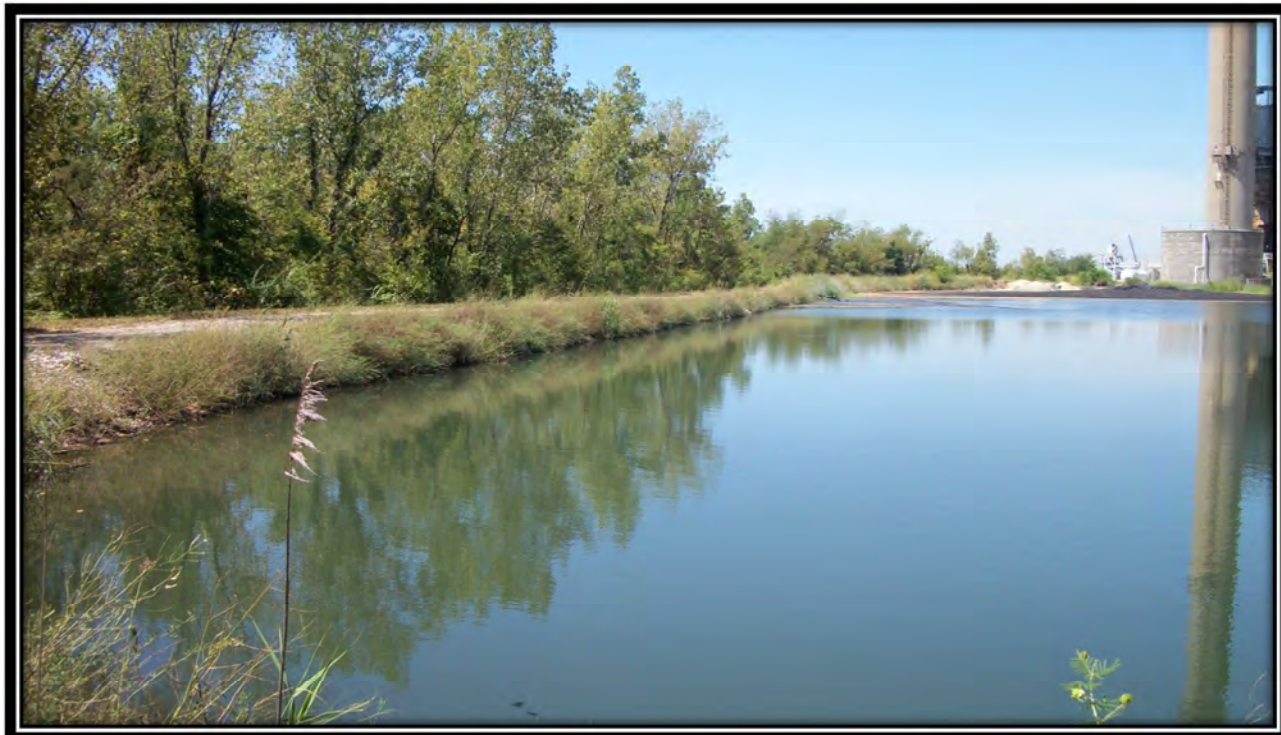
Photo 25 – East pond looking west along upstream south bank

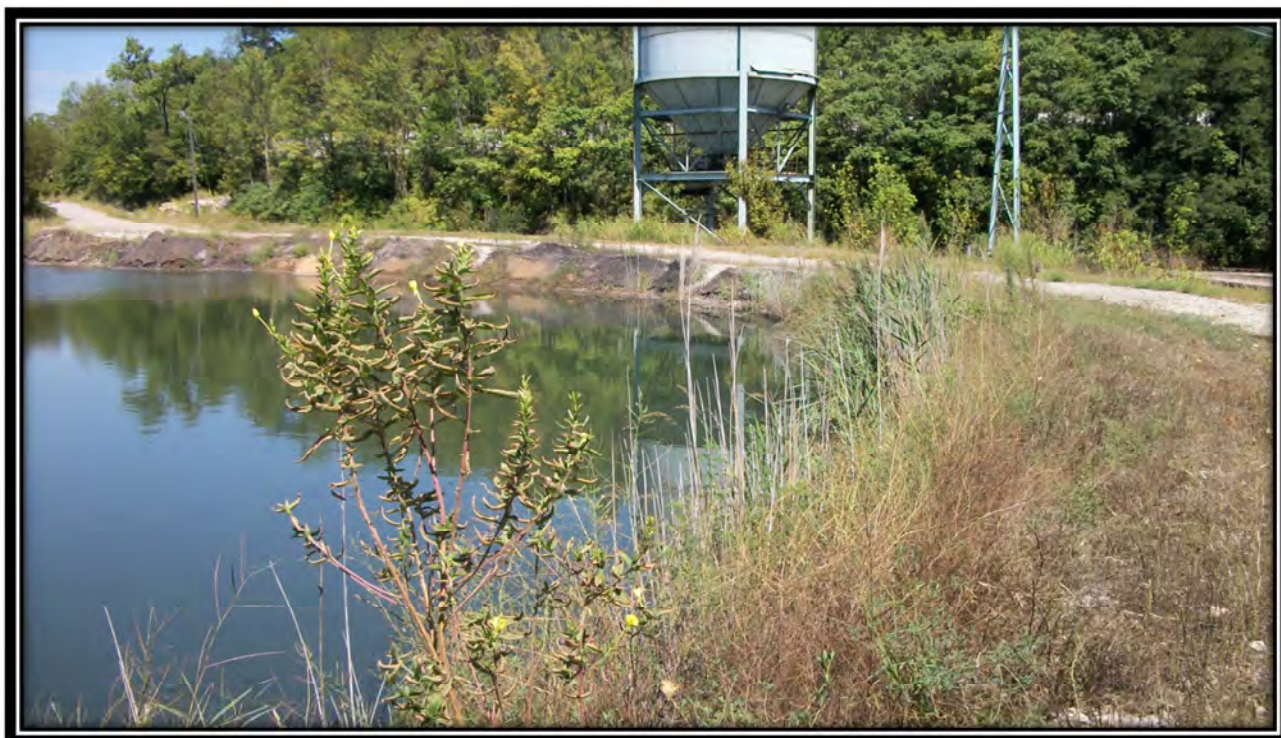
Photo 26 – East pond looking north along upstream east bank

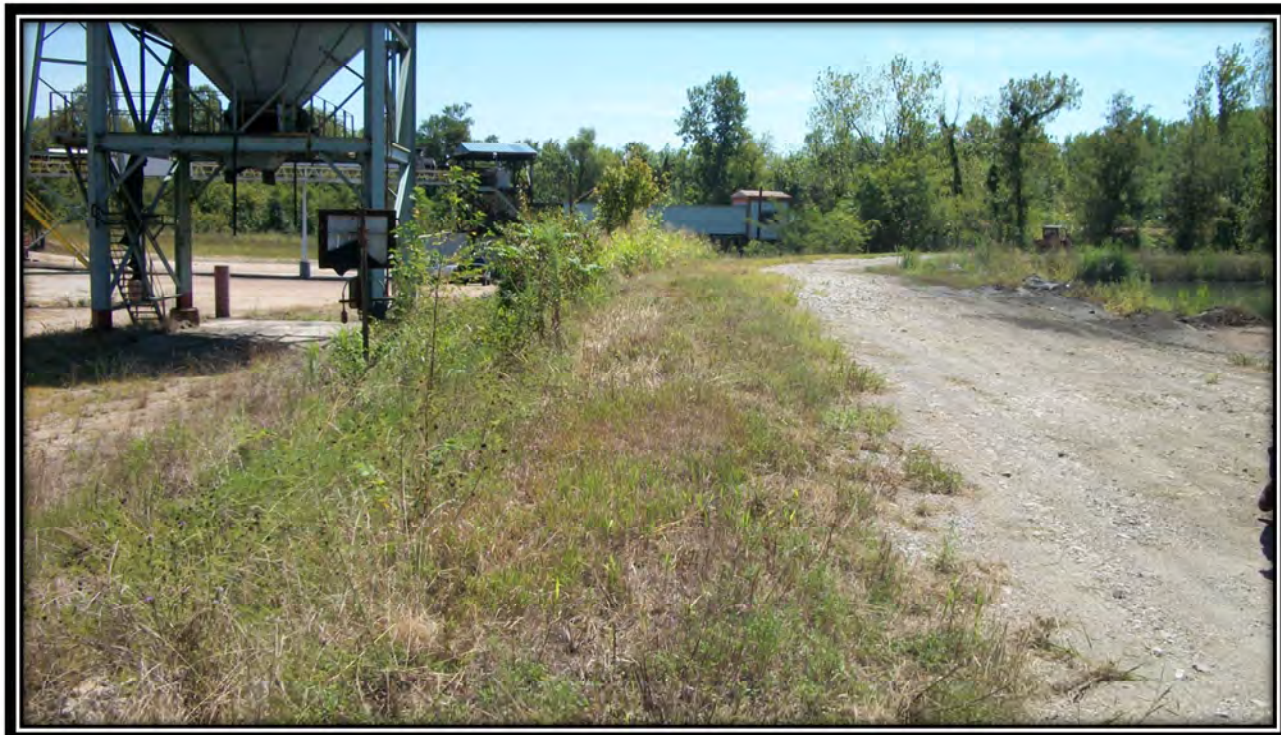
Photo 27 – East pond looking east along downstream north bank near northeast corner

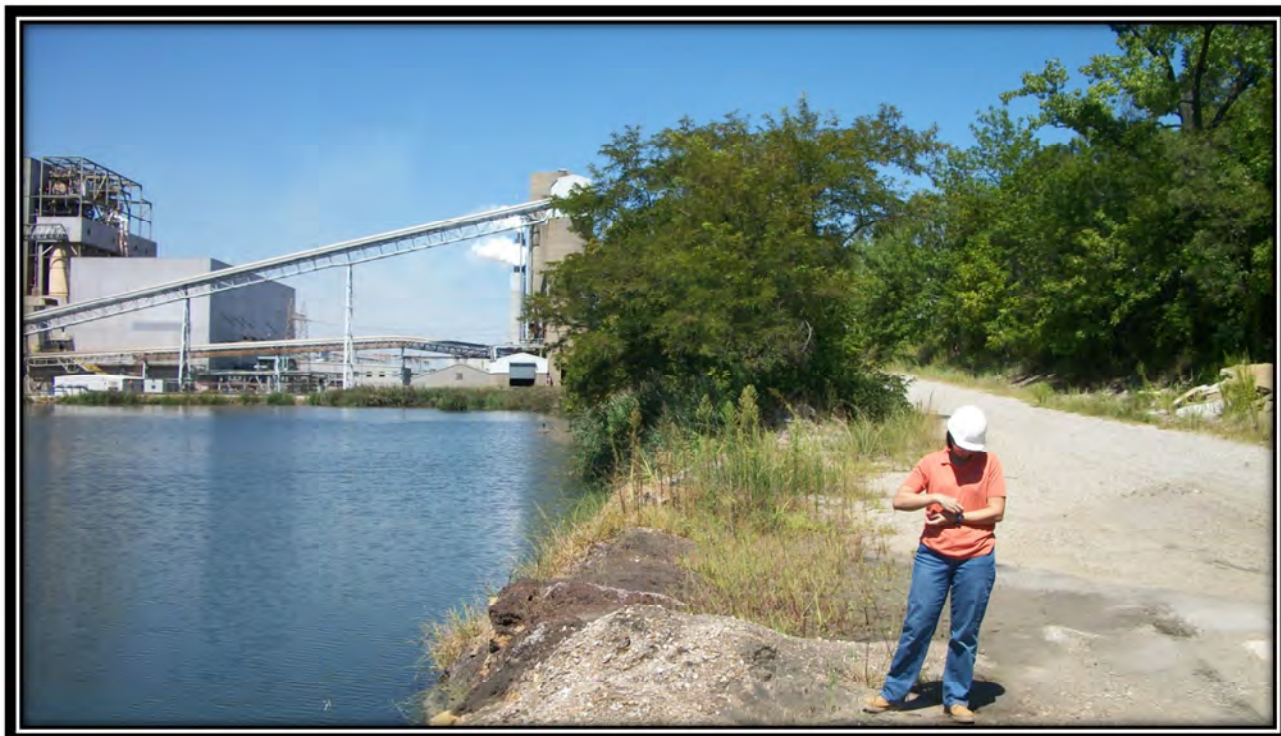
Photo 28 – East pond looking west along upstream north bank

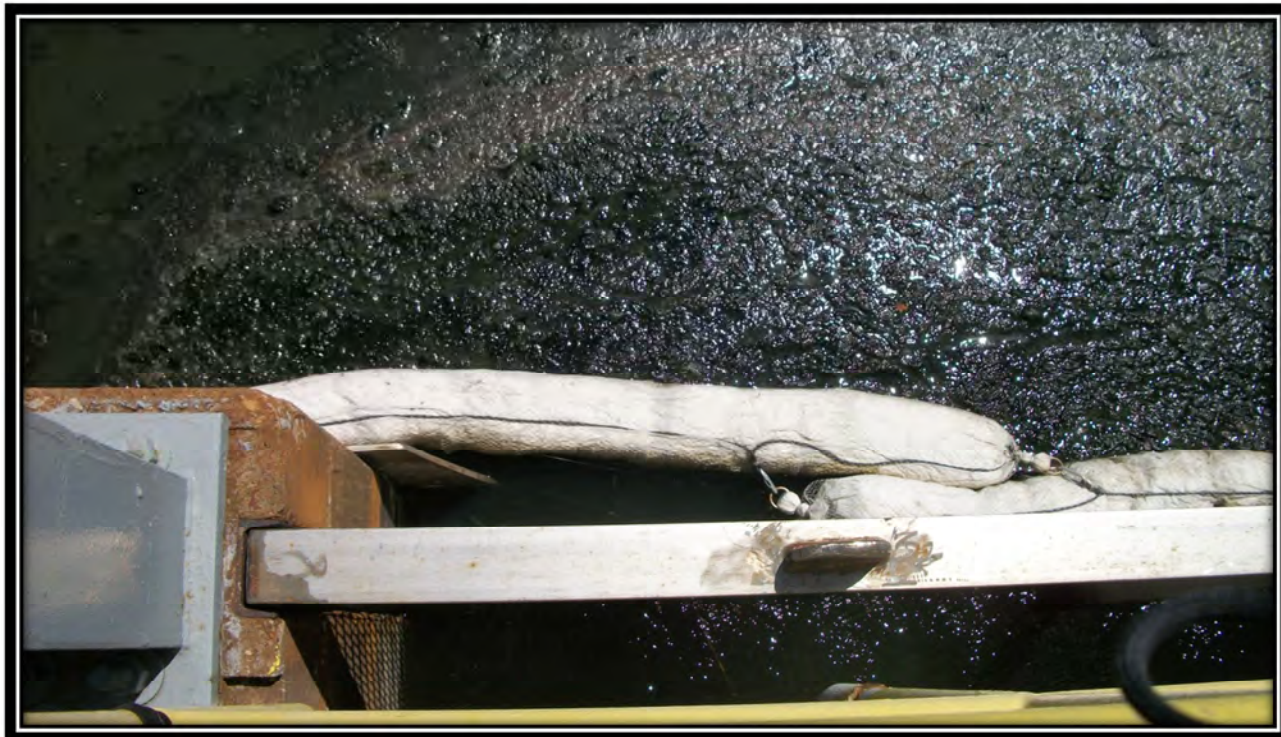
Photo 29 – East pond pump on upstream west bank

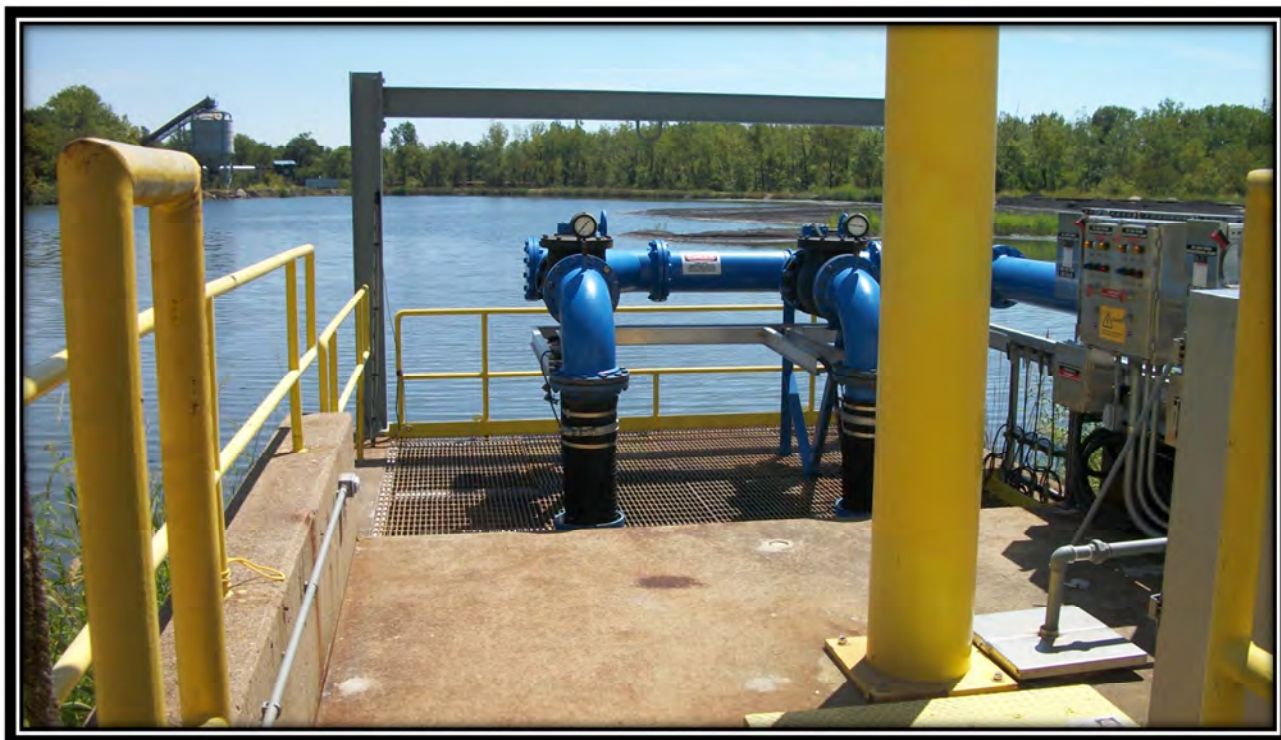
Photo 30 – East pond pump on upstream west bank

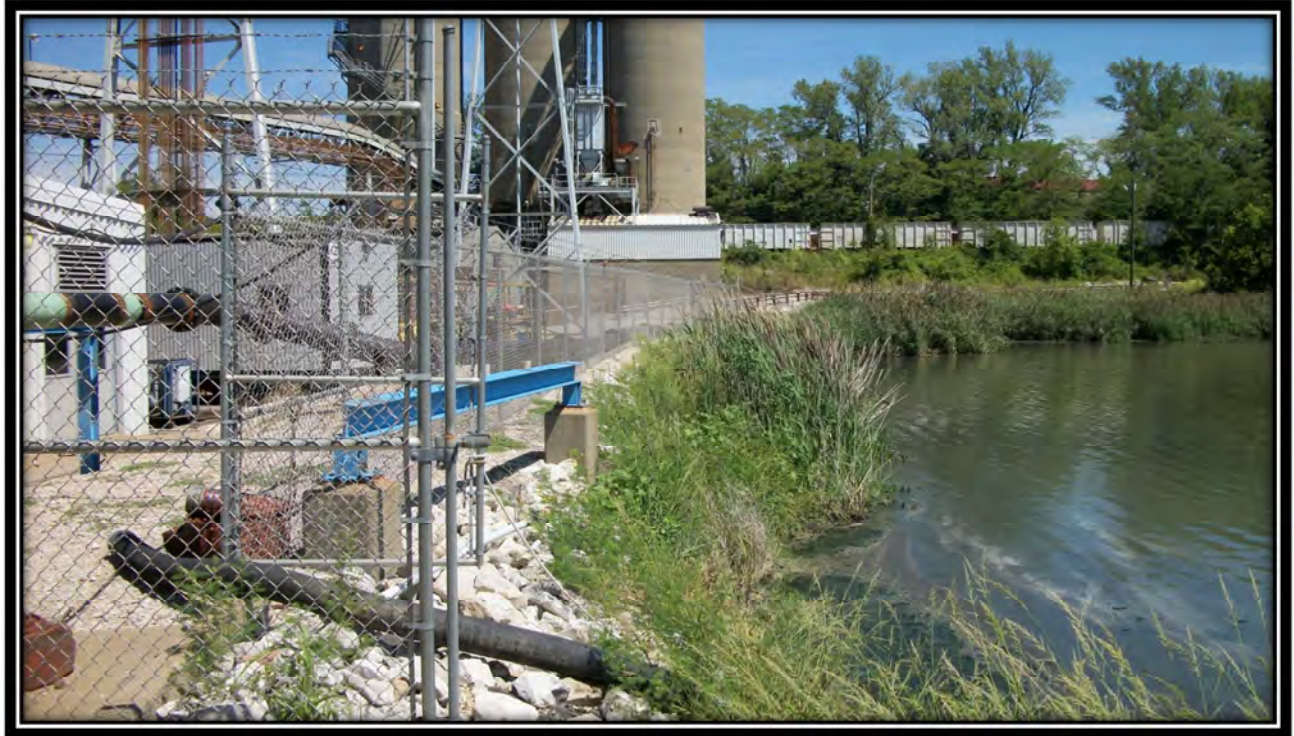
Photo 31 – East pond looking north from pump station along upstream west bank
